STAVIRIZER

Iglesias de madera en Noruega

The stave churches of Norway

By Håkon Christie

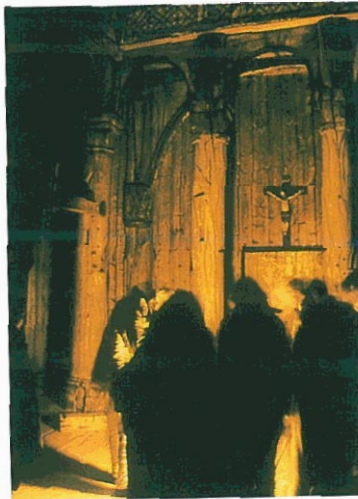
Iglesia de Haltdalen

La mayoría de las iglesias eran pequeñas, simples naves rematadas por tejados de tejas de madera y al igual que los muros, embreados. Internamente, el espacio se prolonga hasta la cumbre. Como el espacio pequeño no puede ampliarse con el aumento de los fieles, particularmente tras la introducción de los bancos de asiento.

La iglesia de Haltdalen ha sido trasladada al Ecomuseo de Trøndelag de Sverresborg, cerca de Trondheim, donde ha sido restaurado hasta su aspecto original y puede estudiarse con detenimiento.

Haltdalen stave church

Most of the Norwegian stave churches were small, simple buildings with a short nave and a narrow chancel. The roofing was usually wooden shingles, and both the roof and the walls were torred. Internally the room extended right up to the ridge of the roof. As the churches were small they could not accommodate the growing congregations, particularly after seating was introduced. Most of the stave churches of this type were demolished, or extended and rebuilt. Haltdalen church has been moved from its site to the Trøndelag Folk Museum at Sverresborg, near Trondheim, where it has been restored to its original appearance.
